# Manhole Inspection Summary

Manhole # S07YY1007MH

**Location** Address: **2901 WHITNEY AVE**

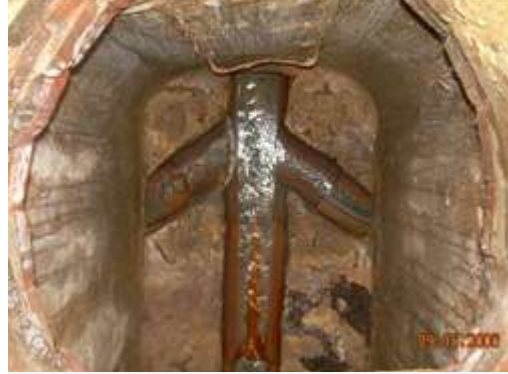
Top View

Corbel and Barrel infiltration. Corroded and missing steps. Evidence of surcharge - Bench debris.

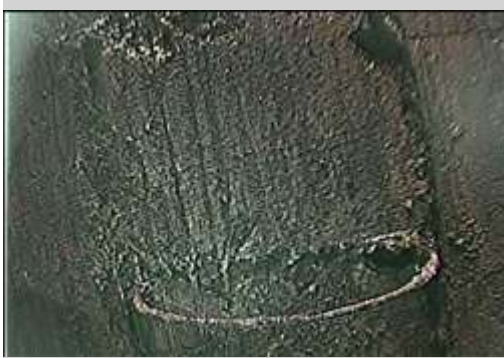
Defect

Corroded and missign steps.

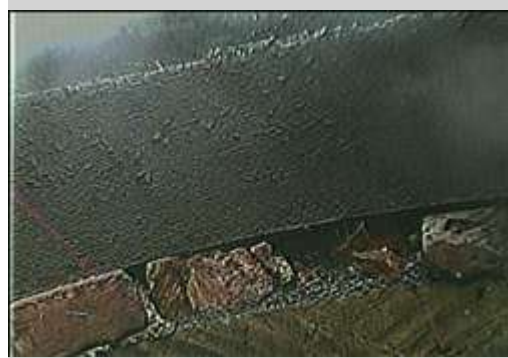
Defect

Frame leaks. Adjustment deterioration, loose brick and infiltration.

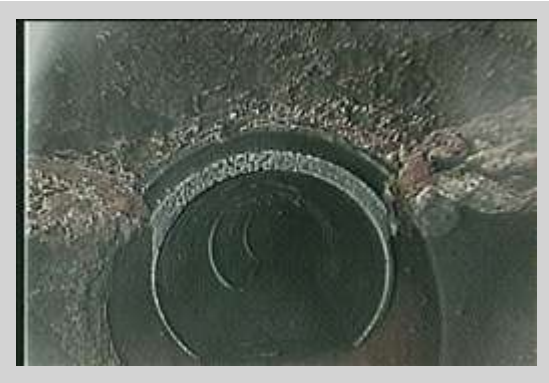
### 10 in. Circular Gravity Sewer Pipe Out @ 12 O'Clock

Infiltration: **None** Pipe Seal Cond: **Unknown**

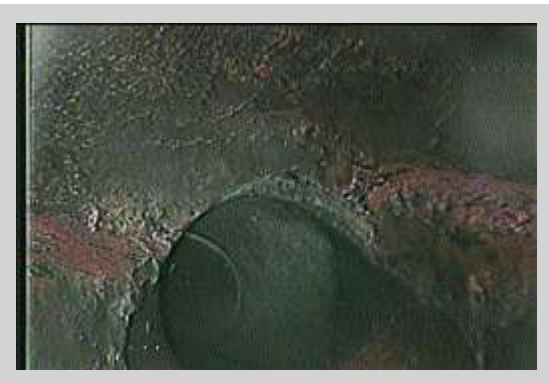
### 8 in. Circular Gravity Sewer Pipe In @ 3 O'Clock

Infiltration: **None** Pipe Seal Cond: **Cracked**

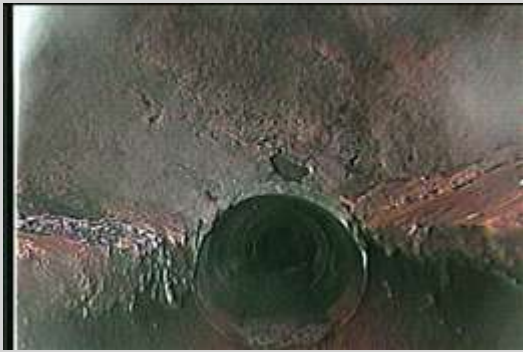
Pipe In @ 6 O'Clock

Infiltration: **Evidence** Pipe Seal Cond: **Broken**

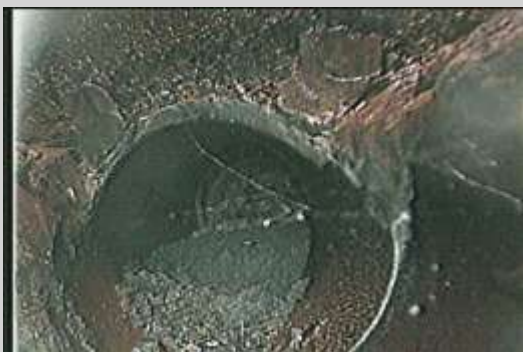
Pipe In @ 9 O'Clock

Plugged.
